ARB Board Order for Demolition

12-063ARB – BSC Historic Core District

North Riverview Redevelopment Demolition 17, 27, 37, 45, 53 North Riverview Street 40 North Blacksmith Lane

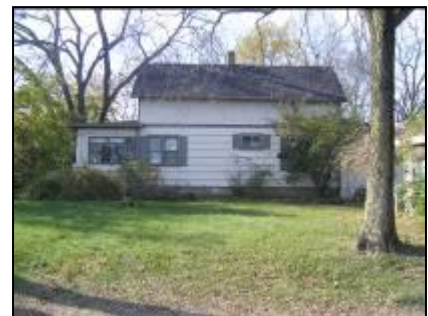
40 East Bridge Street

This two-story gabled ell house was constructed in the late 1800s facing Bridge Street, but the grading required to construct the existing bridge over the Scioto River in the mid-1930s disconnected and isolated the house from Bridge Street. It is enclosed by retaining walls to the south and west and is accessed from North Riverview Street. The house has a stone foundation and is clad with a combination of asbestos and wood siding with an asphalt shingle roof. A portion of the wrap-around front porch has been enclosed, and two one-story additions and a wood deck are present on the rear of the house. An open two-car carport is present along North Riverview Street. An outbuilding clad with asbestos siding and a standing seam metal roof is located along the western retaining wall parallel to North Blacksmith Lane.

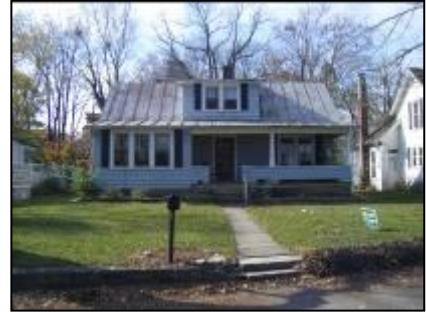
17 North Riverview Street

This 1½ story bungalow was constructed in the 1920s. The house has a rock-faced concrete block foundation, and is clad with wood siding with a standing seam metal roof. The front of the house has a full-width porch that is partially enclosed. At the rear of the lot and accessed from North Blacksmith Lane is a gabled garage clad with a concrete block foundation and clad with vertical wood siding and a standing seam metal roof.

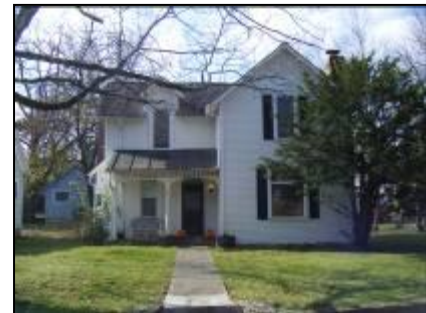
27 North Riverview Street

This two-story gabled ell house was constructed around 1890. It has a stone foundation and is clad with wood shiplap siding with an asphalt shingle roof. The front porch has gingerbread trim and a standing seam metal roof. A two-story carriage house is along North Blacksmith Lane at the intersection with Wing Hill. It is clad with wood shiplap siding and a standing seam metal roof. A shed addition with a corrugated metal roof is located on the east side of the carriage house.

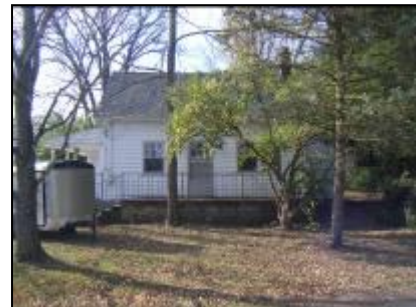
37 North Riverview Street

This 1½ story side gabled house was constructed circa 1920. The house has a variety of foundation materials including rubbed stone and concrete block and is clad in a combination of clapboard, board and batten, and shiplap wood siding and has an asphalt shingle roof. A partially enclosed porch faces Wing Hill and an open concrete deck faces North Riverview Street. Additions were made along the west elevation and at northwest corner of the main house. A small shed is located along North Blacksmith Lane and is clad with wood siding and an asphalt shingle roof.

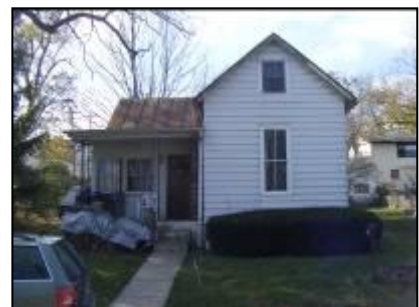
45 North Riverview Street

This 1½ story gabled ell house was constructed around 1880. It has a stone foundation and is clad with aluminum siding with a standing seam metal roof. One story additions are at the angle of the ells and along the rear of the house. A garage is located along North Blacksmith Lane with vertical wood siding and an asphalt shingle roof.

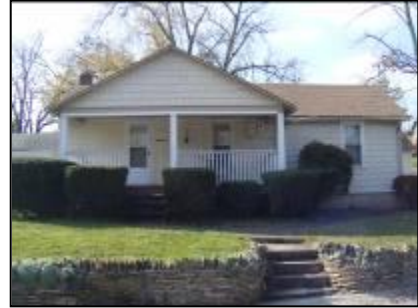
53 North Riverview Street

This one-story side-gabled house was constructed around 1920. The house has concrete block foundation and both the original portion of the house and an apparent addition to the northwest are clad with staggered wood shingle siding. The roof is clad in a combination of asphalt shingles and a rubber membrane over the shallow sloped shed addition. A large front gabled porch is set on concrete block piers. A detached single car garage is present at the rear of the lot at the intersection of North Street and North Blacksmith Lane. It is clad in vertical wood siding with an asphalt shingle roof.
